# **Intel<sup>®</sup> Mobile Celeron<sup>™</sup> Processor Specification Update**

Release Date: November 1999

Order Number: 244444-009

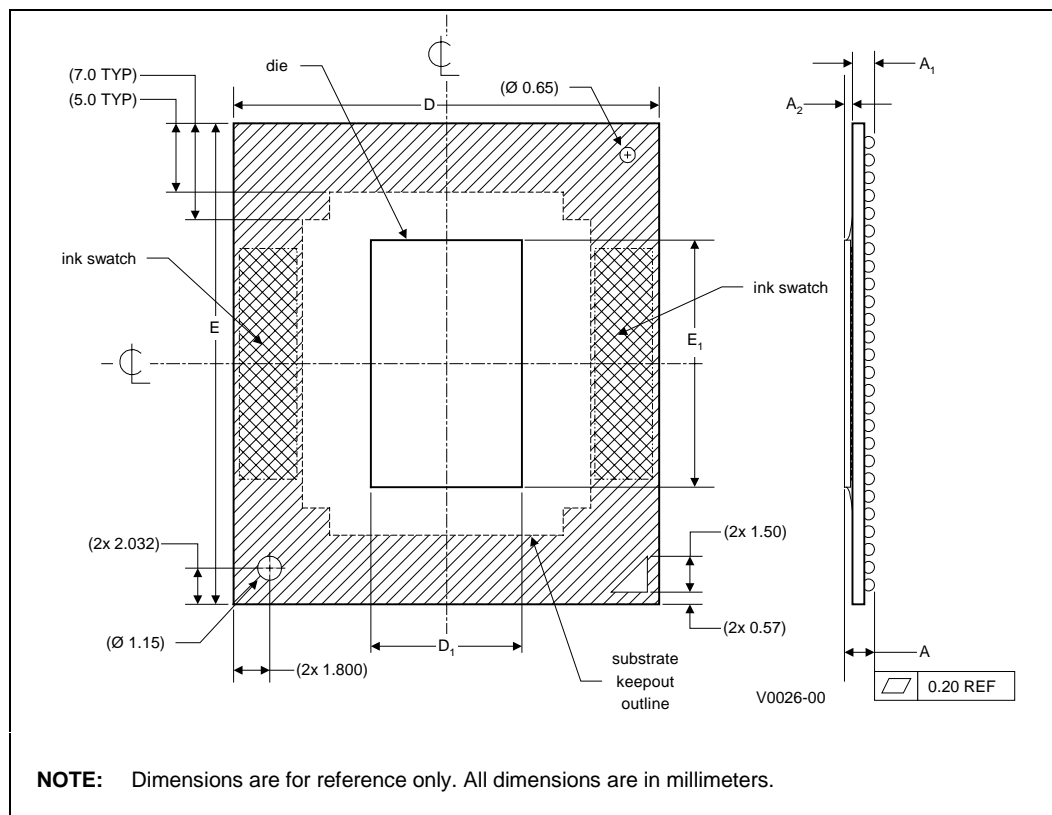
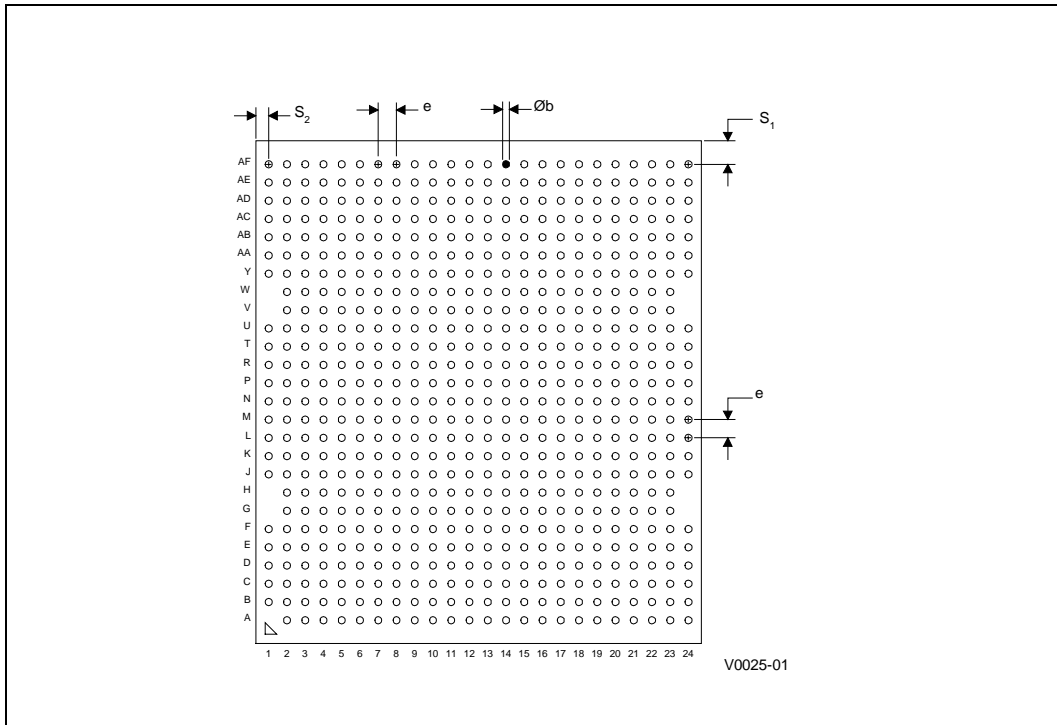
The following table and figures show the updated mechanical specifications for the BGA1 package, listed as Table 5.2, Figure 5.3 and 5.4, respectively, in the *Intel® Mobile Celeron™ Processor in BGA Package at 333 MHz, 300 MHz and 266 MHz* datasheet.

1. The number shown here is different from that in the 244444-004 version of this specification update. The maximum reference number is used.
